Report Prepared for: Jane and John Sample

# Home Inspection Report

123 Sample Street

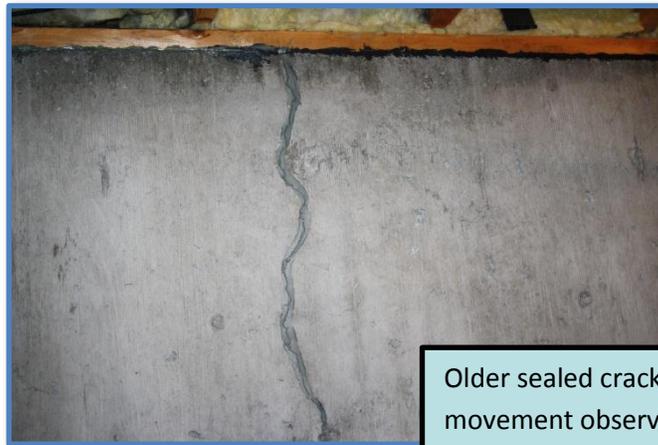
Older sealed crack, no new movement observed.

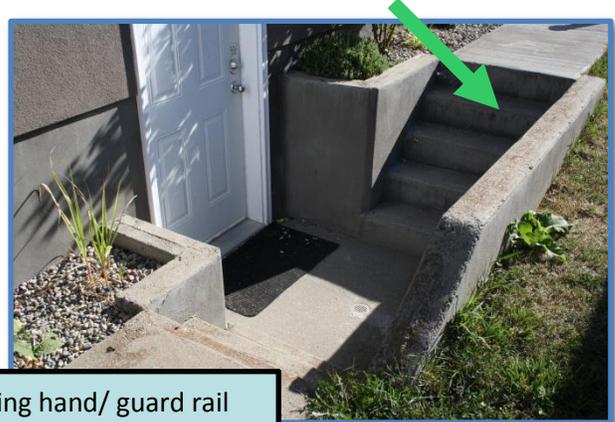
**Basement entry**

The basement can be entered by an exterior entry. There are concrete stairs leading to the basement. A floor drain is present at the bottom of the basement stairs. While the stair case is in satisfactory condition, it is suggested hand rail as well as a guard rail be installed for safety reasons.

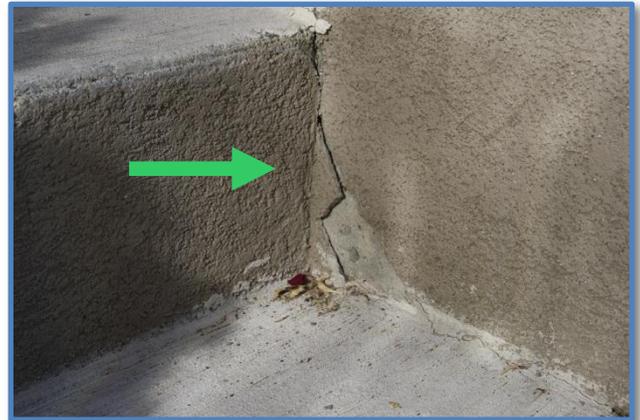
Parging (a thin coat of mortar type material) was applied to the exterior concrete foundation and to the sides of the various concrete stairs around the exterior of the home.. While most of the parging is in good shape, some of it, in particular near the concrete steps leading to the front sun deck, is starting to flake and peel. Parging is applied mostly for esthetic reasons only, and flaking usually does not reflect on the quality of the foundation or concrete work.

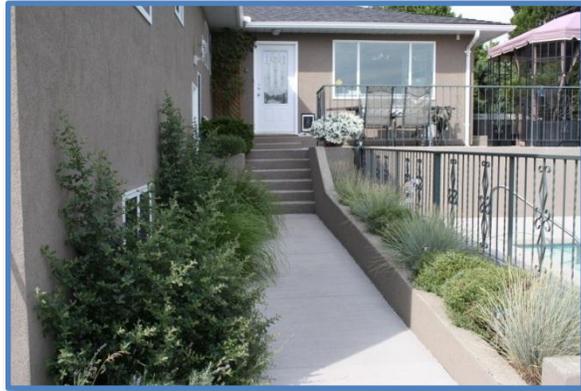
Most trees, plants and shrubs are well away from the dwelling. However, there is some vegetation against the southern and eastern sides of the foundation and home. Having plants so close to the home can lead to insect or vermin infestation, as well as moisture penetration, which can result in damage to the foundation and walls. While this vegetation seems to pose no problems to the dwelling at the time of inspection, I recommend trimming back all vegetation around the perimeter of the home, leaving about 4 inches of clearance between vegetation and the side of the dwelling. Continue to monitor for signs of moisture or insect issues as part of your regular home maintenance regimen.

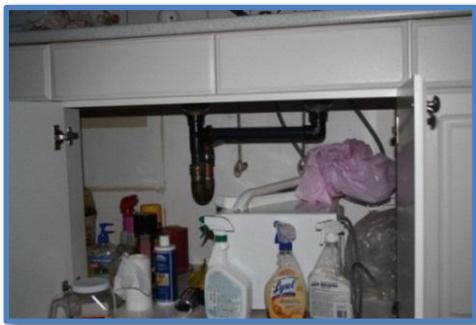
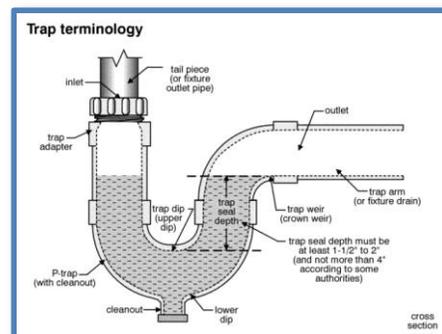
The trap seal depth of the p-trap under the basement kitchen sink is excessive. While no drainage problems were observed at the time of inspection, a trap seal depth of more than approx. 4 inches can cause sludge and waste to build-up resulting in slow draining and clogging. I recommend calling a licensed plumber to remedy the situation.

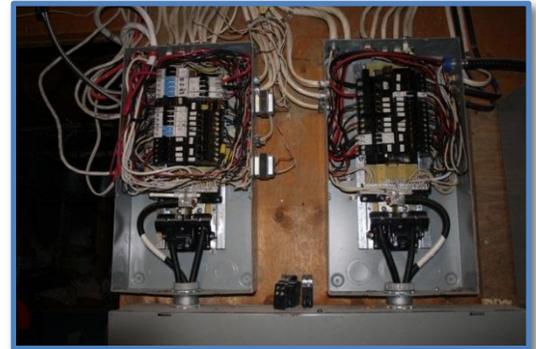
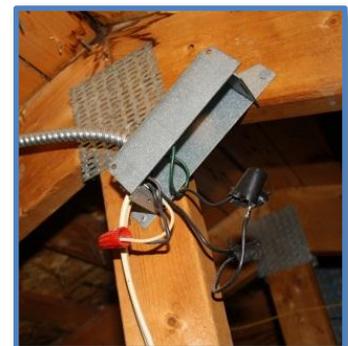
This home used to have an electric attic fan on the roof. The fan has since been disconnected, but the electrical feed for this unit is still present and live in the attic. These wires need to be appropriately capped off in a safe electrical housing with cover for possible future use. Note: the moisture issue that can be seen in the upper corner of the picture was dealt with when the roof was replaced in 2007.

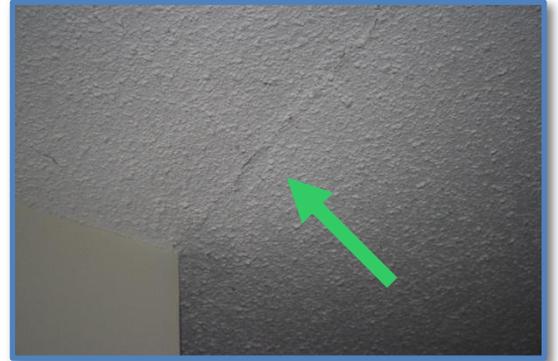
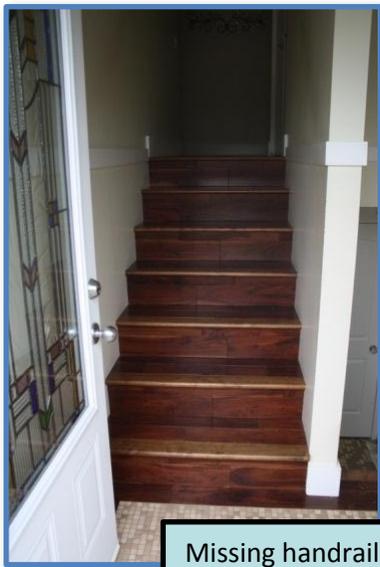
There is a slight crack in the ceiling between the living room and the main hallway. The home owner mentioned the crack gets a bit worse in fall, and then greatly reduces in spring. Because the crack seems to be seasonal, some form of very slight truss uplift in the attic is suspected. Truss uplift is caused when there is a temperature and moisture difference between the top chord and the bottom chord of a truss. The wood in the top chord expands with absorbed moisture from cold winter air in the attic space, while the bottom chord remains stable because it is protected by the insulation and the heat coming from the house. As the top chord expands it forces the bottom chord to arch up. Structurally this is not a problem, but in this case it does produce a slight seasonal crack in the tape joint of the ceiling drywall. If the crack is found esthetically displeasing I suggest installing a nice trim over the crack, which will cover the contracting and expanding crack throughout the seasons.

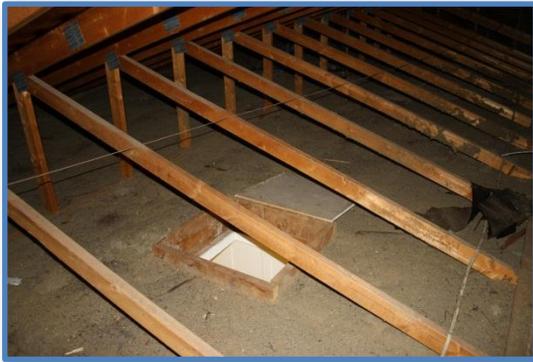
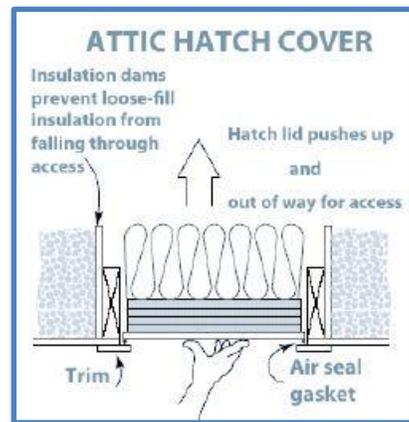
The attic access hatch is not sealed nor insulated. This may cause some energy loss through convection. The warm air leaking into the attic area may further cause staining of the roof sheathing above the hatch area as it condenses on the cold roof sheathing and captures dust particles from the air. It is recommended that the hatch be weather stripped and insulated to the same approximate R value as the rest of the attic.
