HOME INSPECTION REPORT

123 SAMPLE STREET

Jeanine Reiss - AHI
FYI Home Inspections Ltd

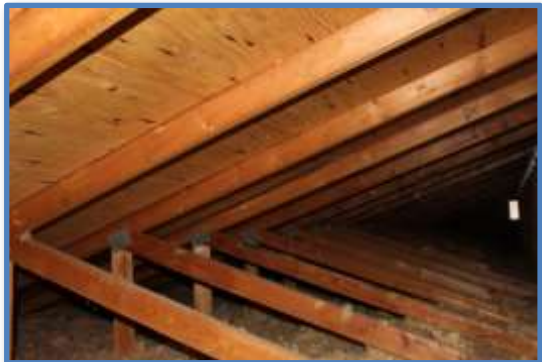
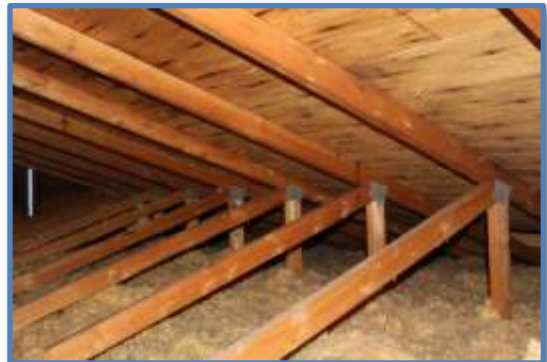
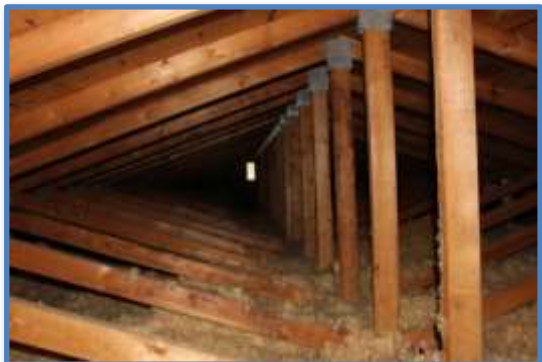
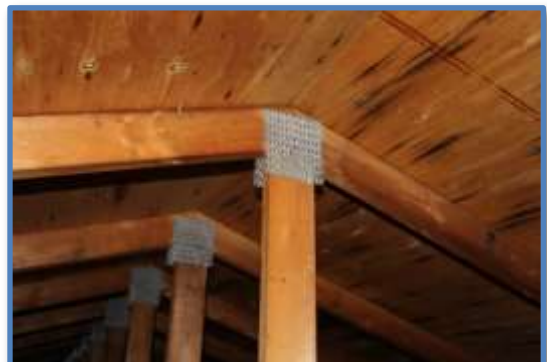
Inspection of attic revealed some staining and possible mildew or mold formation on the roof sheathing in particular above the main floor bathroom and at the western section of the attic. Staining and microbial growth occurs for two reasons: a roof leak or condensation. The vast majority of cases involve condensation, which occurs when an exhaust vent, such as a bathroom or kitchen vent, exhausts into the attic and / or the attic is not properly ventilated and not able to adequately exhaust damp air created by the occupants. When the temperature of the attic sheathing drops below the dew point small droplets of water accumulate on the roof sheathing creating an environment conducive to trapping dust particles and eventually to mold growth. In the case of this home staining and microbial formation is likely due to both condensation due to lack of ventilation and possibly the main floor bathroom vent that used to vent into the attic rather than the exterior. Please refer to the INSULATION AND VENTILATION section of this report on how to improve ventilation and to halt further condensation and staining.

At this time, the staining has not yet lead to any structural damage. It is recommended to improve venting by adding baffles to the soffit areas and also by ensuring the bathroom vent line exhausts to the exterior. Staining can be left as is providing ventilation issues have been properly dealt with and no new staining occurs.

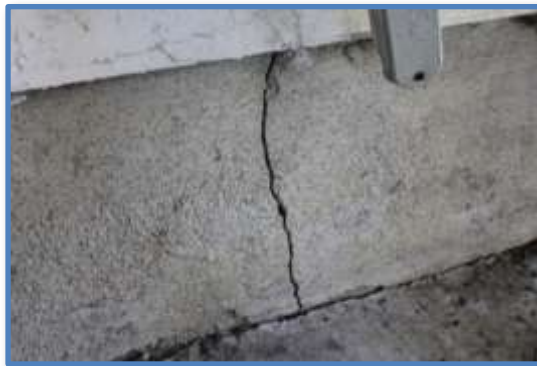
The concrete foundation viewable in the basement and at the exterior perimeter of the home shows random signs of some settlement and shrinkage cracks. Some slope towards the north was noted within the basement and main floors. All residential foundations settle to some degree over the lifespan of the home. Such movement is not considered structurally significant. This foundation has probably reached final compaction, and unless something significant happens, like an unforeseen major flood or seismic activity, it is not likely to settle significantly more.

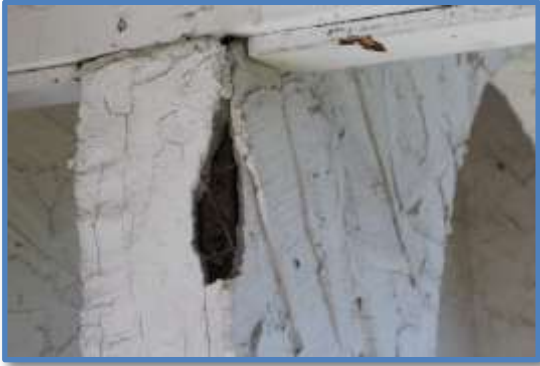
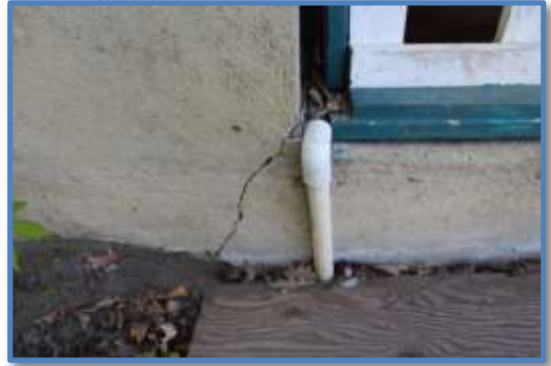
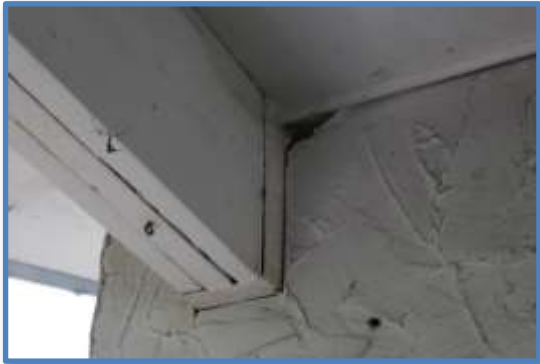
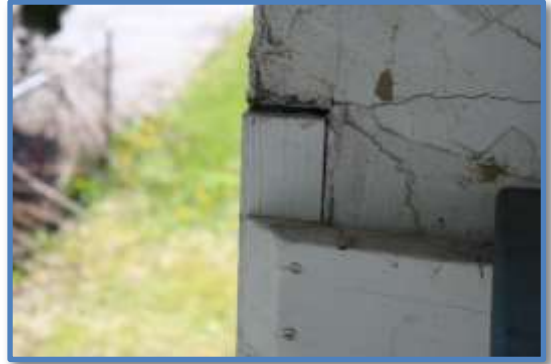
- Patch / repair / seal all holes / openings, cracks wider than 1mm in stucco to help prevent moisture, insect, or vermin penetration. For instance:

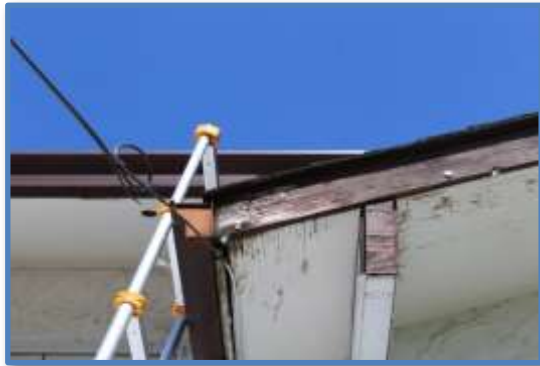
- Keep all exposed wood surfaces, including fascia, soffits, gable ends, well-painted to protect against weathering and deterioration.

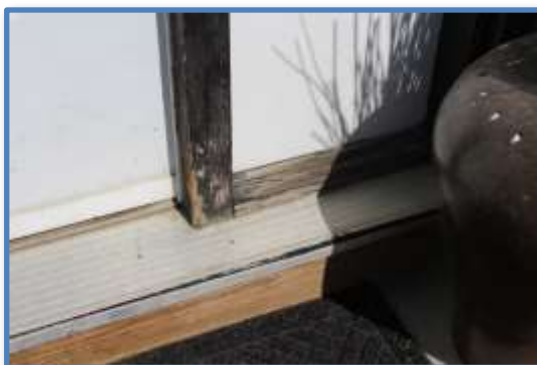
- Keep any wood trim well-painted to protect from weathering and deterioration.

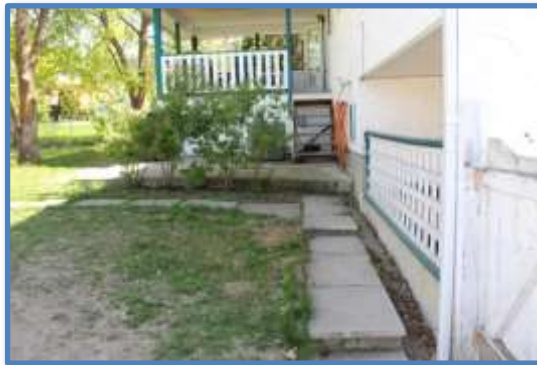
- The walkway along the back of the home is showing some movement and differential settling between slabs. Monitor for trip hazards and correct as needed.

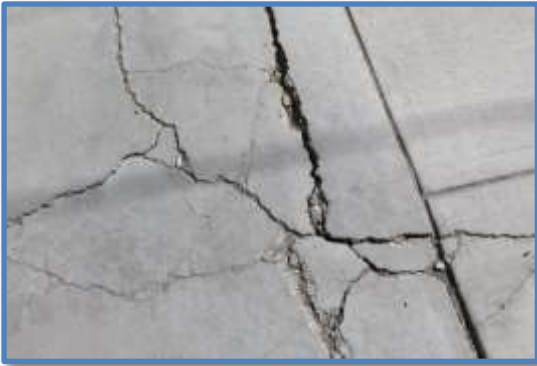
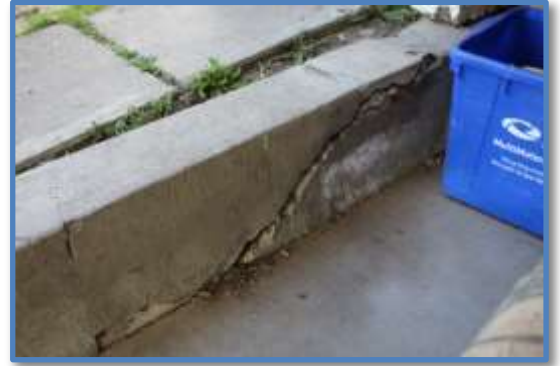
- The carport floor and concrete pony wall have cracks due to settling. Monitor for continued movement and patch/ repair if needed to help prevent further deterioration due to moisture and freeze / thaw cycles.

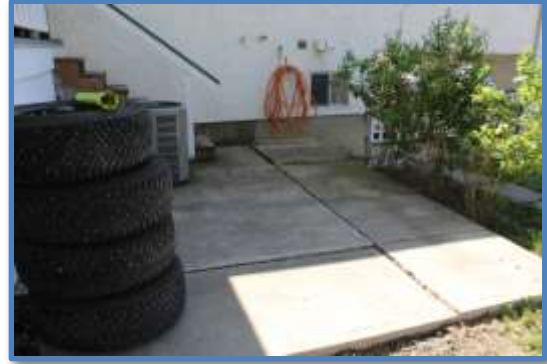
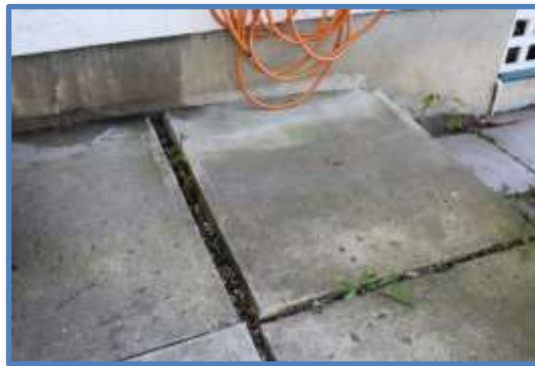
Movement and differential settling has occurred between the various concrete slabs. Movement may continue or may have slowed down. Monitor and maintain as needed. Watch for trip hazards.

It is recommended to discourage plants / weeds from growing between the slabs (e.g. lilac shoots) to help prevent movement of slabs.

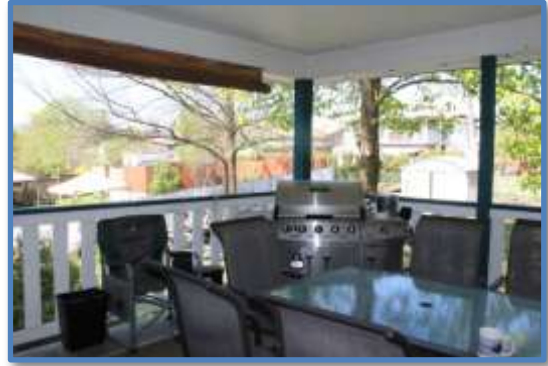
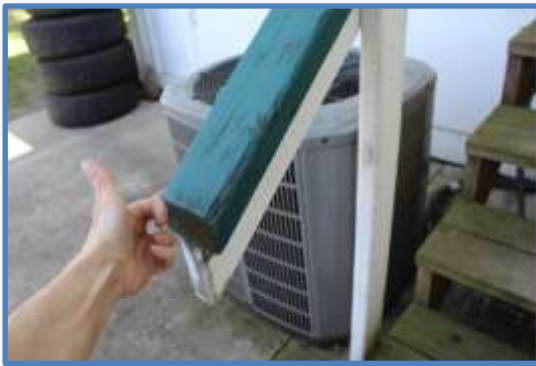
- The hand rail to the sun deck is wobbly and lacks integrity. Replace hand rail with spindled hand rail for safety and convenience and to protect children from falling off the stairs sideways.

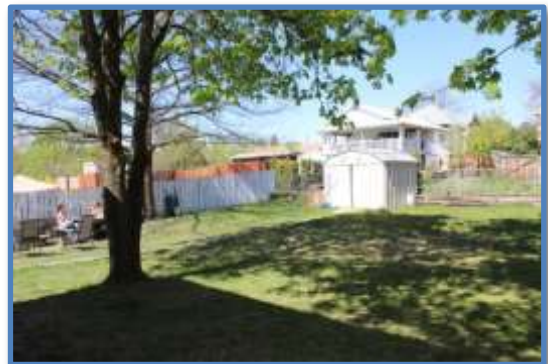
Wood fencing is in differing states of condition.

- Repair and maintain fencing as needed
- Correct leaning
- Remove wood-on grade where possible
- Paint / stain wood to protect and extend life

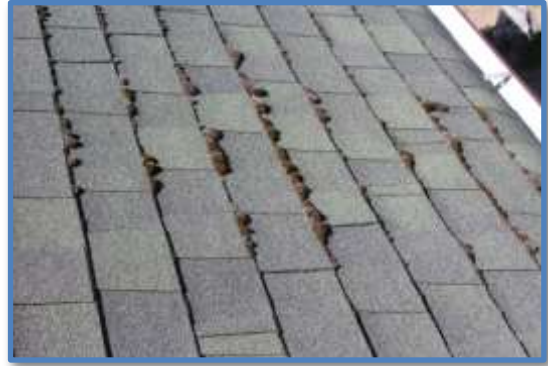
The northern facing slope is showing some moss growth. While moss itself does not damage the roof surface, it does retain water, making it harder for the roof to dry out between precipitations. A wet roof tends to age more prematurely. It is recommended to remove the moss by gently brushing it downward (it should come off quite easily). Monitor slope for new growth, and install zinc strips if needed.

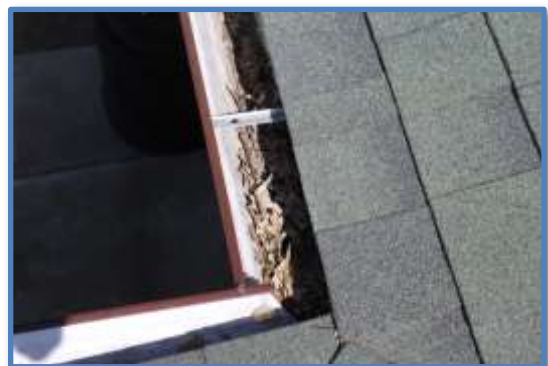
- The gutters are full of leaves and debris and are in need of cleaning.

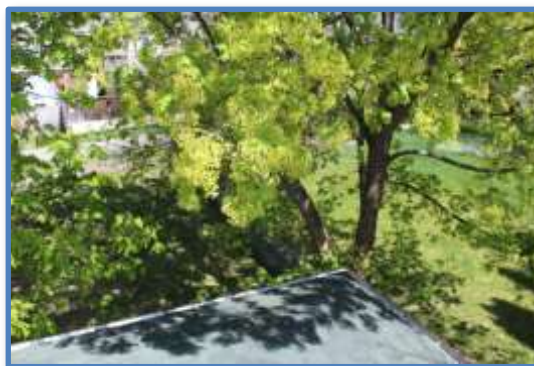
Some of the trees or branches, in particular on the north-side of the home and sundeck, overhang the roof. This condition, if allowed to continue, could result in damage to the roof covering. It is recommended to keep branches trimmed back at least two feet from the roof and wall surfaces.

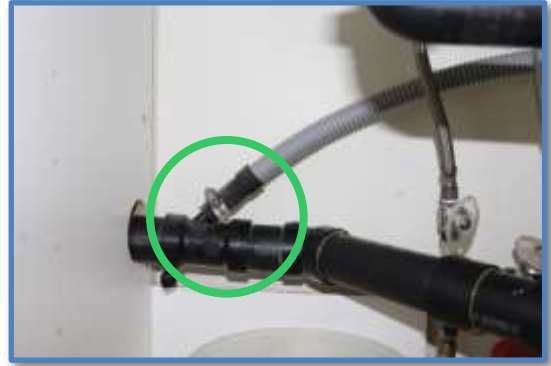
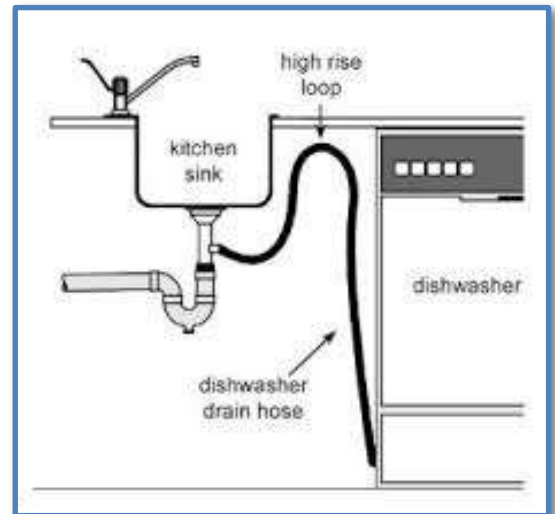
- There is some movement in the kitchen faucet. Attempt to tighten so alleviate stress on fixture and water lines.
- The dishwasher drain is connected *after* the P-trap (under the sink). This may allow sewer gases to come back into the dishwasher. It is recommended to connect the line *before* the P-trap so that the water that always sits in the P-trap will prevent sewer gases from coming into the dishwasher and home.
- The dishwasher does not have a high loop installed in the drain line. A high loop is meant to prevent wastewater from being siphoned back into the dishwasher and contaminating its contents. Install high-loop as needed.

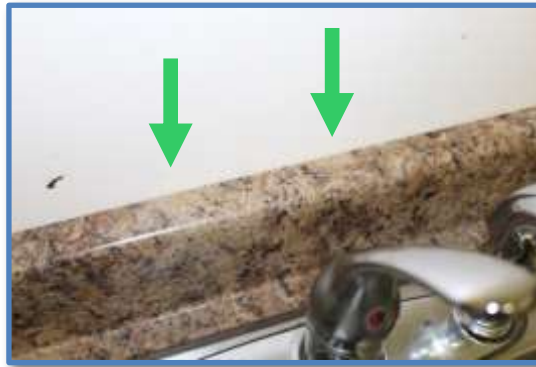
- Silicone caulking is needed along the countertop where it meets the wall to protect vulnerable joint against water penetration.

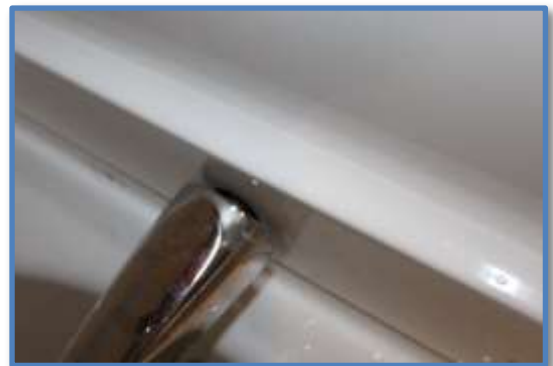
- There is movement in the tub spout, which means there is movement in the plumbing. Movement can hard on the plumbing lines. Luckily, there is access to the plumbing behind the washer and dryer in, what used to be the en-suite bathroom. Secure plumbing lines as needed to alleviate movement. The tub spout also sits proud instead of flush with the surround. Loosen spout (there is a screw at the bottom), reposition and re-attach as needed so the tub is flush with the surround. If uncomfortable with plumbing work, hire a licensed plumber.

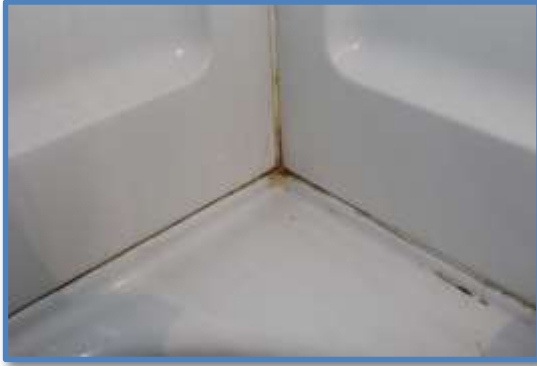
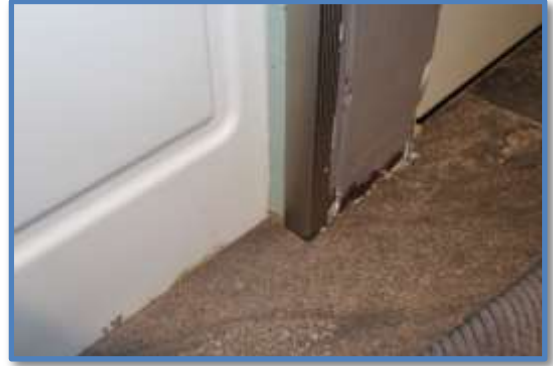
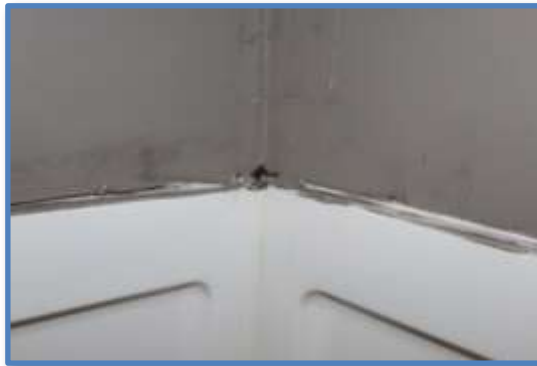
- Silicone caulking is needed in various locations within and along the tub / floor to help protect vulnerable areas against water penetration. It is probably easiest to remove all old and stained caulking and to start again instead of attempting to touch-up.

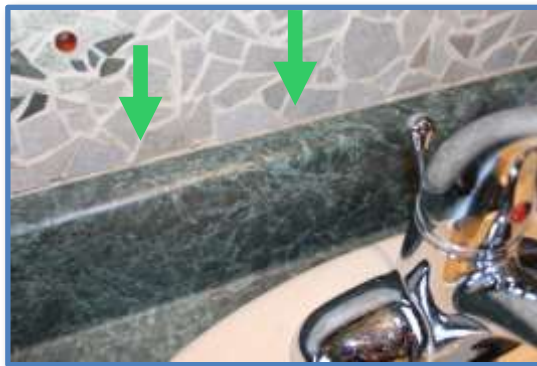
- Silicone caulking is needed along the countertop where it meets the backsplash to seal out moisture.

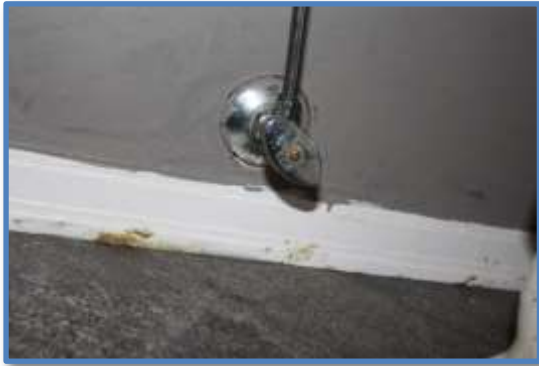
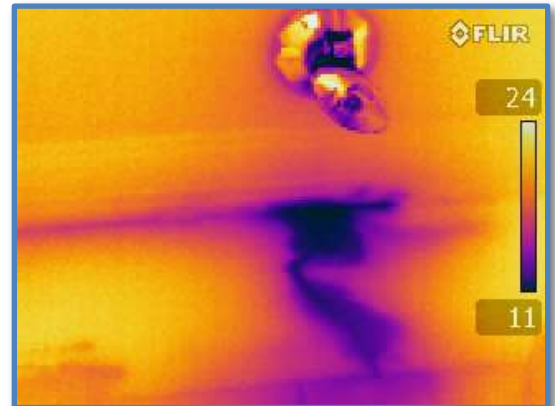
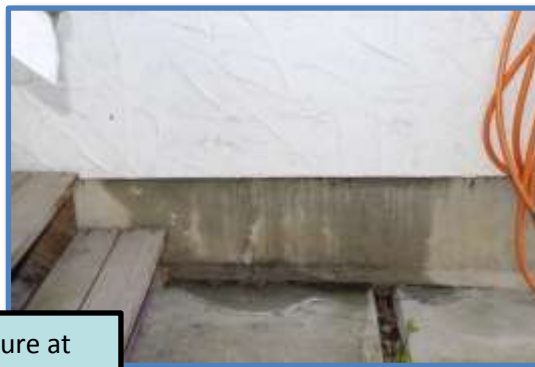
- The toilet isolation valve is leaking steadily. Water has been getting under the floor and is leaking into the basement (viewable behind the stained suspended ceiling panel in the basement kitchen). Signs of moisture were observed at the exterior wall near this bathroom and it is suspected that water due to the leaky toilet valve is finding its way into the wall.

Substantial amount of moisture at the exterior wall and foundation

It is recommended to repair or replace the leaky toilet valve as soon as possible to stop the water leak. Affected areas should be allowed to dry out. Wall should be opened up (possibly from within the basement kitchen) and assessed for water damage and microbial growth (potential health issue). Remedy as needed and allow wall interior and structure to dry out before re-finishing.

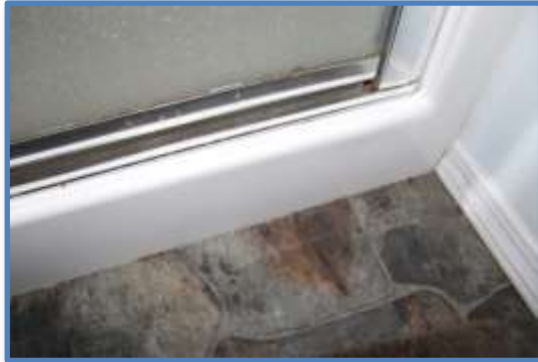
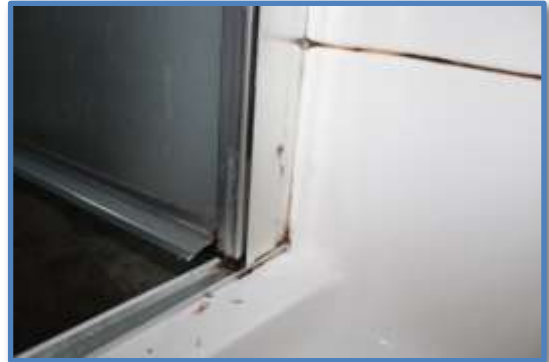
- Silicone caulking is needed (remove any stained caulking first) in various locations to help protect vulnerable areas against water penetration. It is recommended to silicone caulk along:
 - ✓ the base to the shower where it meets the vinyl floor
 - ✓ all corners and joints within the shower surround, including along the shower door
 - ✓ the porcelain sink where it meets the wall.

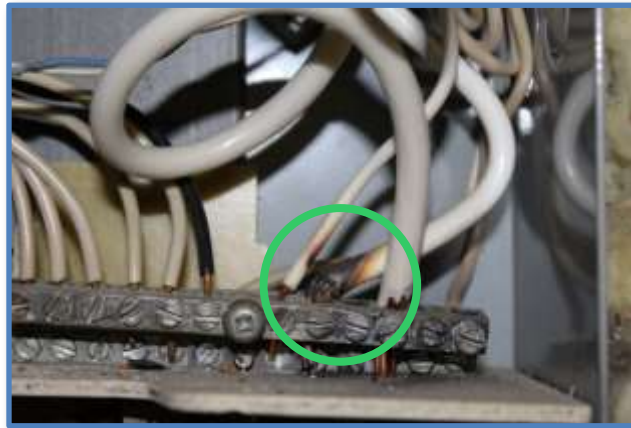
- Signs of overheating was noted at a wire near the neutral bar within the main electrical panel, with blackening, melting of wire apparent. This is a safety issue and a potential fire hazard. It is recommended to have the issue assessed and corrected by a licensed electrician as soon as possible.

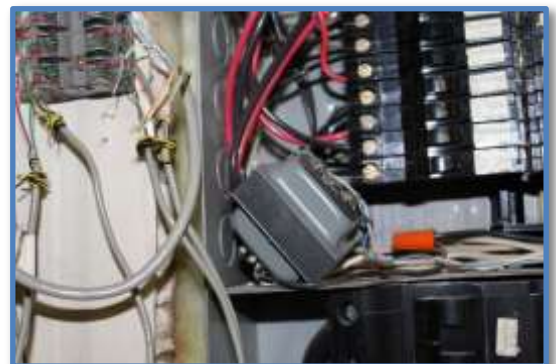
- A transformer was found inside the main electrical panel. This is poor practice. Transformers should be installed outside the electrical panel as per electrical regulations. Correct as needed by a licensed electrician.

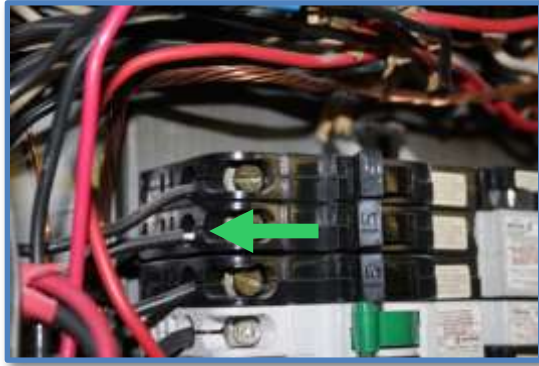
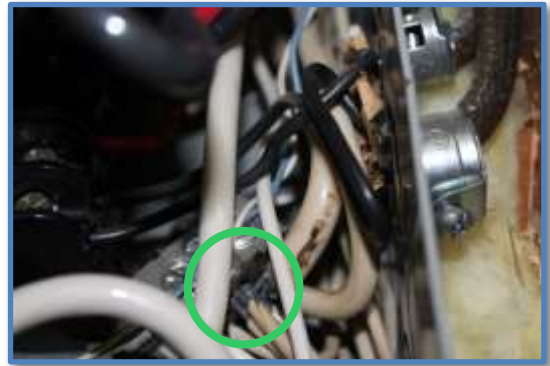
- The home has a combination of copper and solid aluminum branch wiring.

- ✓ Replace all the switches and receptacles with new ones that are rated for aluminum.
- ✓ Rejuvenate all aluminum connections with crimp connectors
- ✓ Rewire the house with new copper wire.

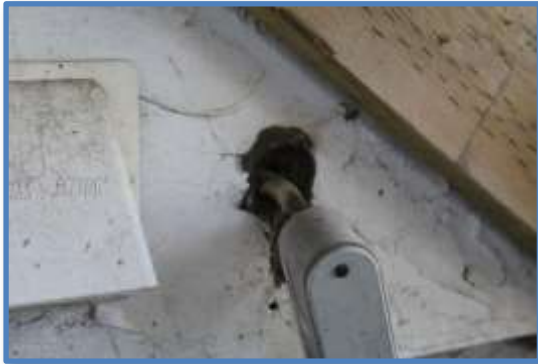
- A loose electrical conduit body was found under the balcony stairs. Re-anchor to wall as needed.

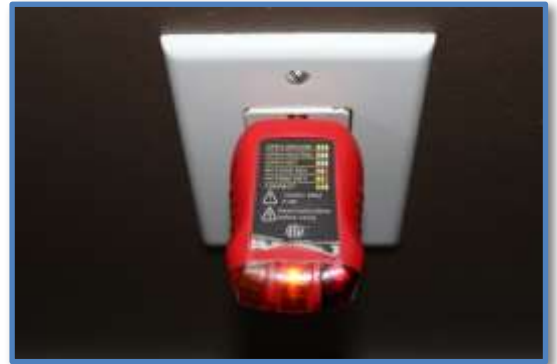
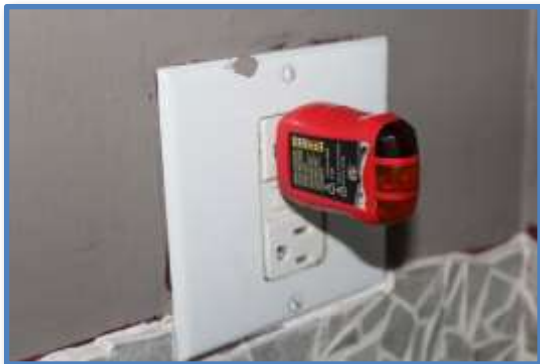
- One or more of the electrical outlets in the master bedroom appear to have their hot / neutral wires reversed. Assess and correct as needed.

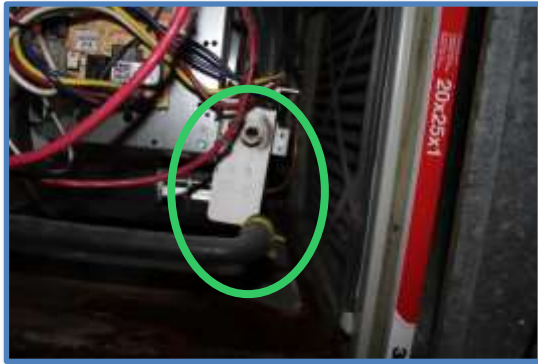
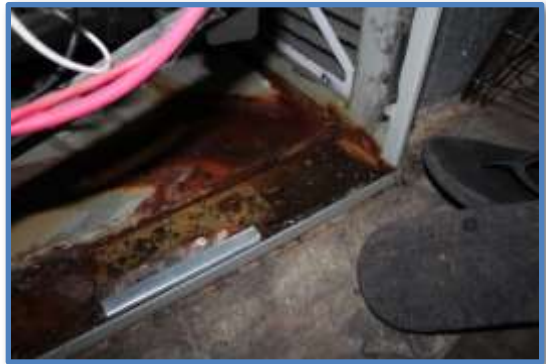
Heating systems last longer and perform more efficiently when serviced every other year. This furnace, while fully operational, is in need of servicing.

- The condensate drain line was found to be detached allowing condensate to drip into the furnace cabinet. Looking at the corrosion this has been going on for a long time. Line was re-attached by inspector, but furnace remains to be in need of servicing.

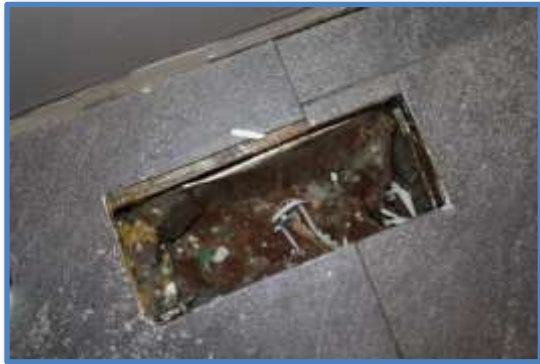
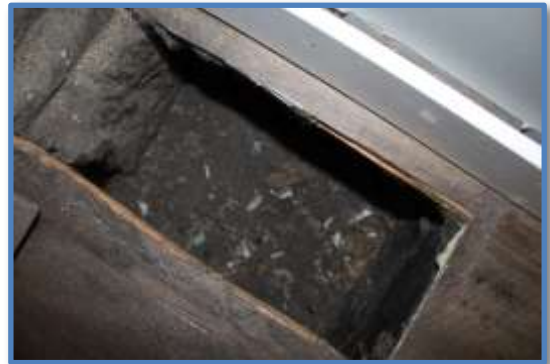
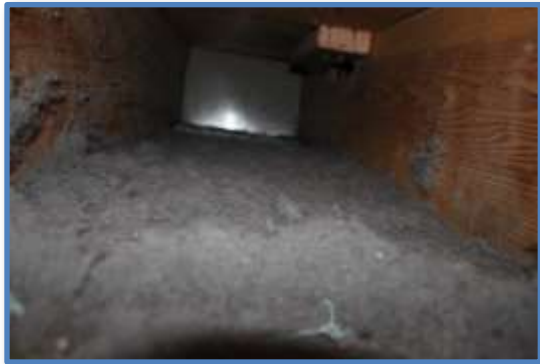
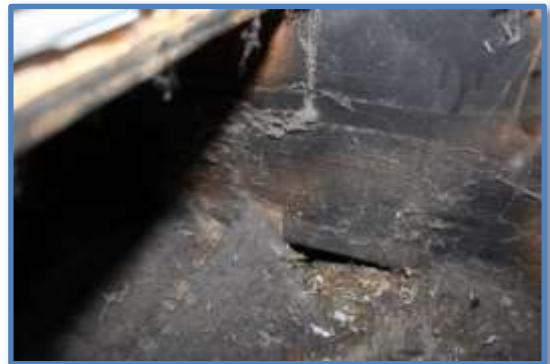
- Supply and return ducting have not been cleaned in long time and are extremely dirty. This puts a lot of stress on the furnace as it has to work very hard to maintain airflow. It is recommended to have the ducts professionally cleaned as soon as possible to alleviate stress on the furnace and to improve air quality and airflow.
- Ducting at several heat registers, and also at the returns, appear damaged or are not properly sealed. This leads to energy loss. Repair as needed.

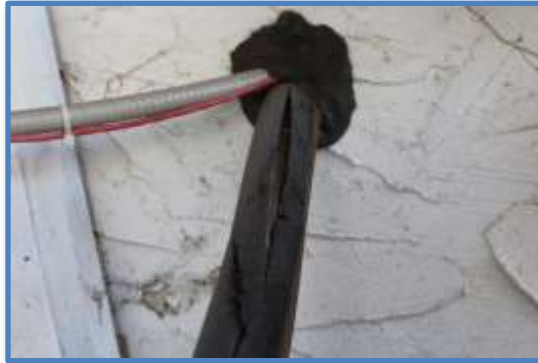
- The insulation around the thicker copper line near the exterior unit has deteriorated. This can lead to efficiency loss and condensation. Re-apply tubing insulation. The thin copper line should not be insulated.

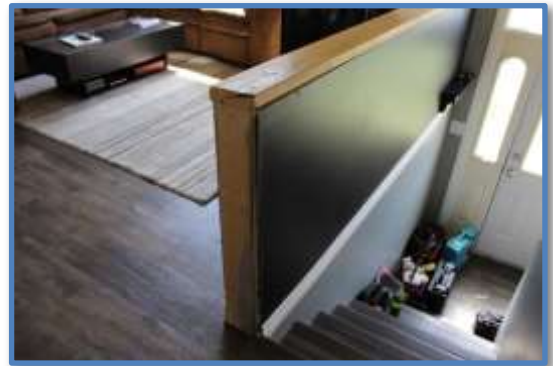
- The guard rail / pony wall between the living room and the stairway shows movement and lacks integrity. Make repairs as needed.

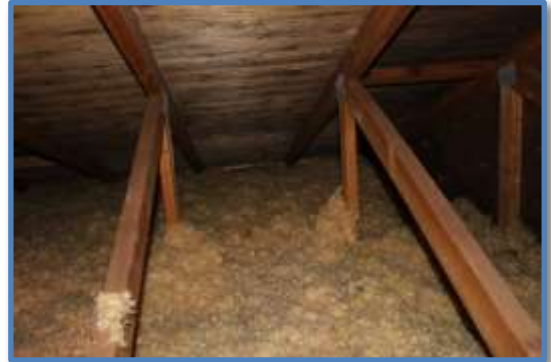
Some staining was noted on the roof sheathing. This is a sign ventilation may be lacking. It is recommended to add baffles at the eaves to improve air intake at the soffits.

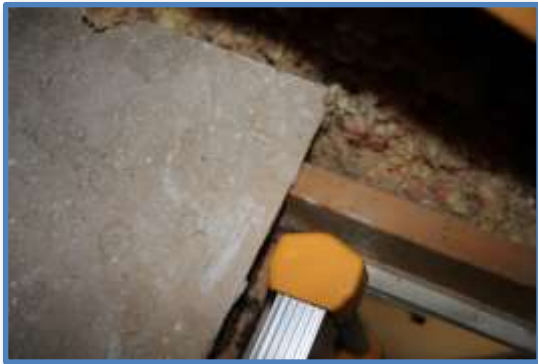
- The attic access hatch is not sealed nor insulated. This may cause some energy loss through convection. The warm air leaking into the attic area may further cause staining of the roof sheathing above the hatch area as it condenses on the cold roof sheathing and captures dust particles from the air. It is recommended that the hatch be weather stripped and insulated to the same approximate R value as the rest of the attic.
