Report Prepared for: Jane and John Sample

# Home Inspection Report

123 Sample Street

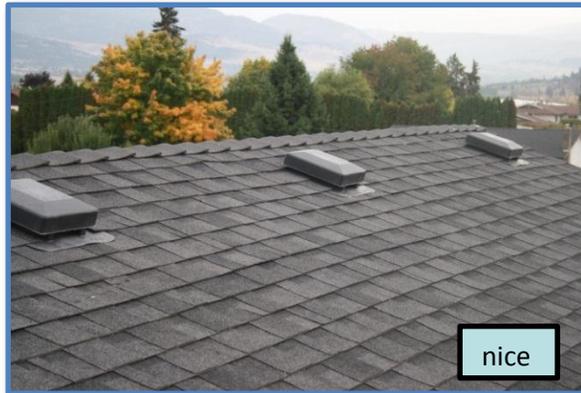
According to the owner this roof is from 2007. Typical life expectancy of asphalt/fibreglass shingles is generally 30-40 years depending of the quality of product. The roof is aging normally.

Roof penetrations (plumbing stack, roof vents, etc) seem to be in satisfactory condition from what could be seen. Roof penetrations should be checked for cracks and breaks, proper caulking as part of regular roof maintenance. Exposed nails should be sealed.

Some of the down spouts go under-ground, others empty onto grade. It is suggested that gutters that empty onto grade are extended at least 4 to 6 feet away from the home and foundation to prevent possible water issues.

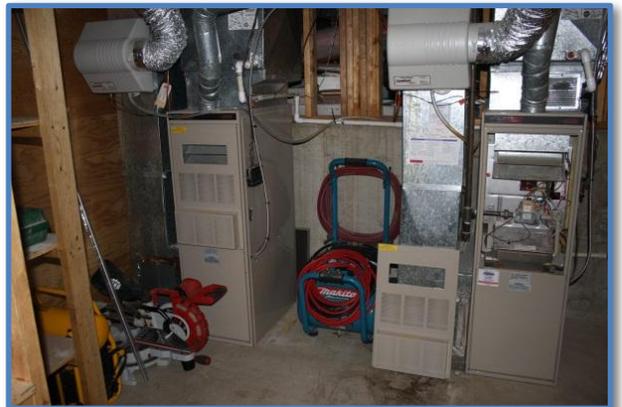
The presence of two humidifiers near the furnaces was noted. They are programmable by the same thermostats that run the central air conditioners/furnaces. The humidifiers were shut off at the time of inspection and not tested.

To maintain air flow and quality it is recommended that furnace filters are cleaned or replaced no less than four times a year.
