HOME INSPECTION REPORT

123 SAMPLE STREET

Jeanine Reiss - AHI
FYI Home Inspections Ltd

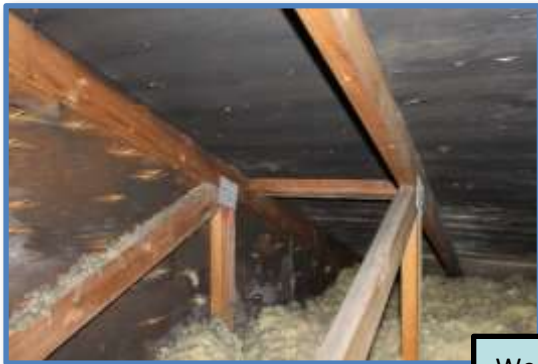
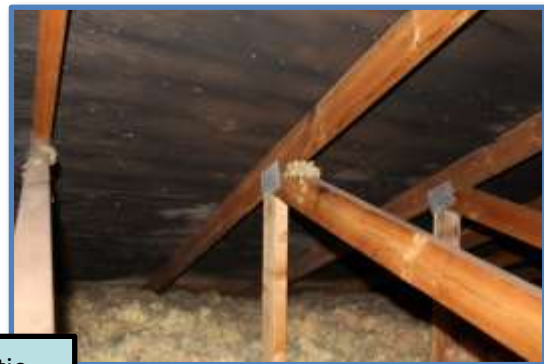
Western side of attic

Inspection of attic revealed some staining and possible mildew or mold formation on the roof sheathing in particular above the main floor bathroom and at the western section of the attic. Staining and microbial growth occurs for two reasons: a roof leak or condensation. The vast majority of cases involve condensation, which occurs when an exhaust vent, such as a bathroom or kitchen vent, exhausts into the attic and / or the attic is not properly ventilated and not able to adequately exhaust damp air created by the occupants. When the temperature of the attic sheathing drops below the dew point small droplets of water accumulate on the roof sheathing creating an environment conducive to trapping dust particles and eventually to mold growth. In the case of this home staining and microbial formation is likely due to both condensation due to lack of ventilation and possibly the main floor bathroom vent that used to vent into the attic rather than the exterior. Please refer to the INSULATION AND VENTILATION section of this report on how to improve ventilation and to halt further condensation and staining.

At this time, the staining has not yet lead to any structural damage. It is recommended to improve venting by adding baffles to the soffit areas and also by ensuring the bathroom vent line exhausts to the exterior. Staining can be left as is providing ventilation issues have been properly dealt with and no new staining occurs.

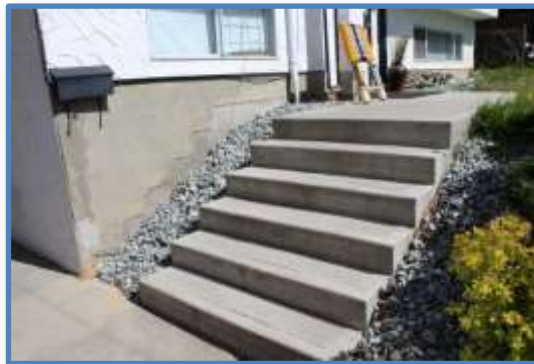
- The concrete stairs to the front entry need to have a hand rail installed for safety and convenience.

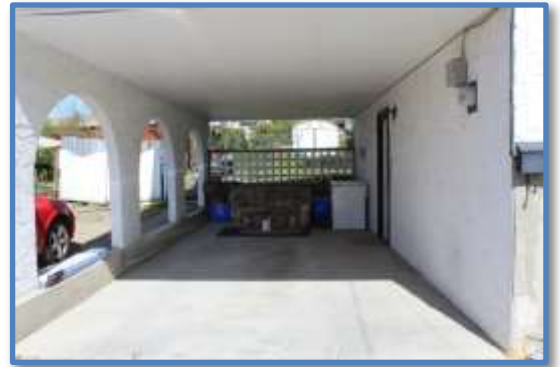
- The carport floor and concrete pony wall have cracks due to settling. Monitor for continued movement and patch/ repair if needed to help prevent further deterioration due to moisture and freeze / thaw cycles.

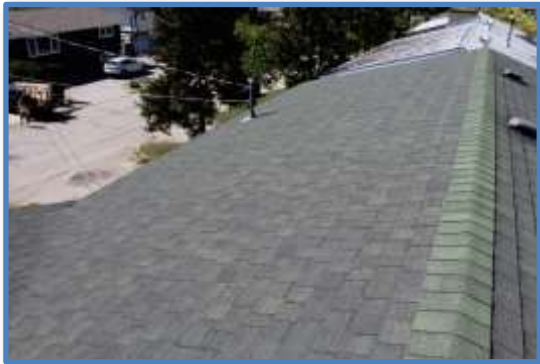
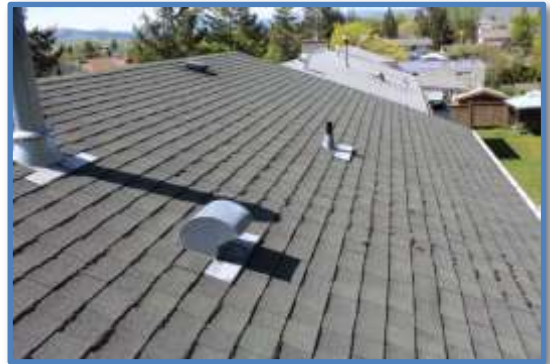
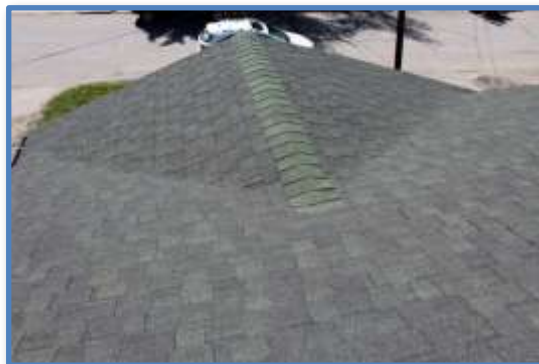
The northern facing slope is showing some moss growth. While moss itself does not damage the roof surface, it does retain water, making it harder for the roof to dry out between precipitations. A wet roof tends to age more prematurely. It is recommended to remove the moss by gently brushing it downward (it should come off quite easily). Monitor slope for new growth, and install zinc strips if needed.

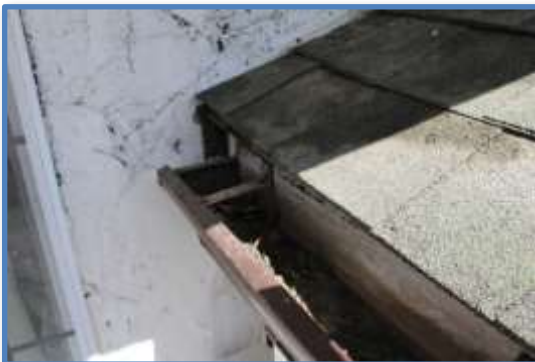
- Monitor gutter at the roof over the front porch as it slopes towards the home and may spill / splash onto the stucco if the gutter and nearby downspout are plugged (they are currently plugged).

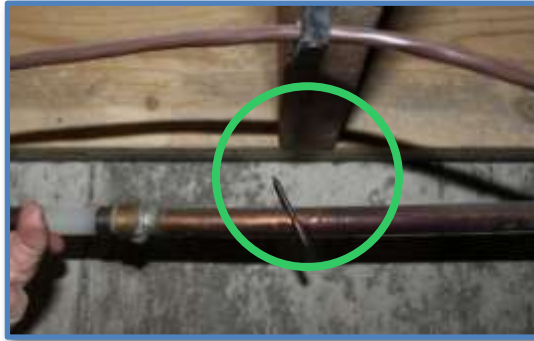
- Some added support is needed to the plumbing supply lines, viewable in storage area under the stairs, to help prevent stress on the water lines.

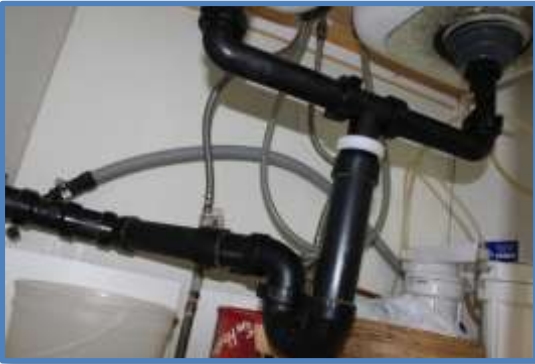
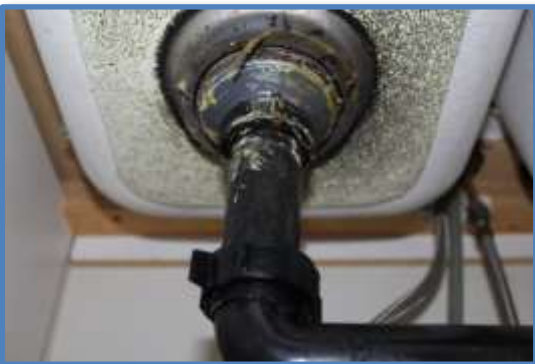
- There is some movement in the kitchen faucet. Attempt to tighten so alleviate stress on fixture and water lines.
- The dishwasher drain is connected *after* the P-trap (under the sink). This may allow sewer gases to come back into the dishwasher. It is recommended to connect the line *before* the P-trap so that the water that always sits in the P-trap will prevent sewer gases from coming into the dishwasher and home.
- The dishwasher does not have a high loop installed in the drain line. A high loop is meant to prevent wastewater from being siphoned back into the dishwasher and contaminating its contents. Install high-loop as needed.

- While no leak was observed, caulking and connections under the left-hand sink look troublesome. Monitor until ensured there are no latent leaks.

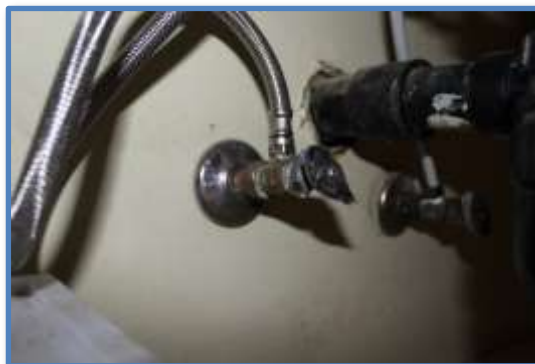
- The isolation valves under the sink appear older and over-handled. Replace as needed to help prevent leaks in the future.

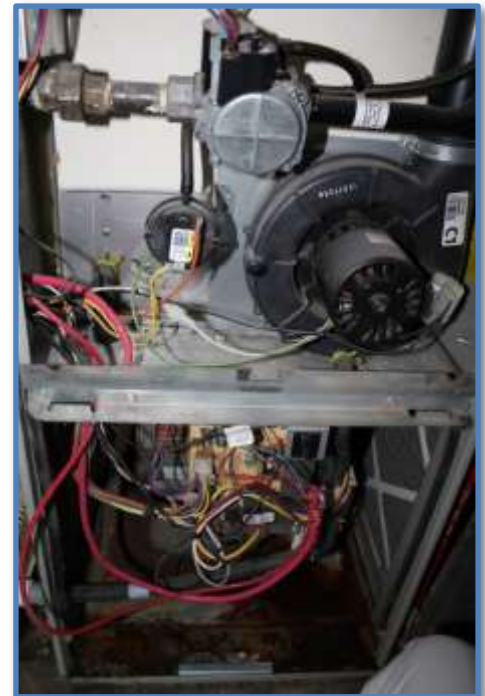
Heating systems last longer and perform more efficiently when serviced every other year. This furnace, while fully operational, is in need of servicing.

- The condensate drain line was found to be detached allowing condensate to drip into the furnace cabinet. Looking at the corrosion this has been going on for a long time. Line was re-attached by inspector, but furnace remains to be in need of servicing.

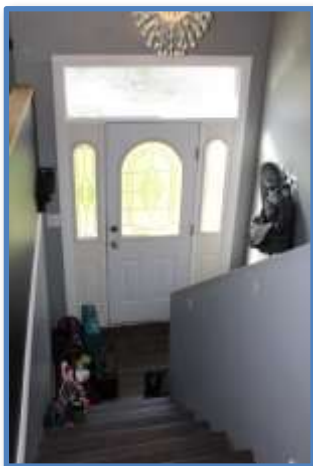
- The stairway from entry level to main floor is missing a hand rail. Install for safety and convenience.

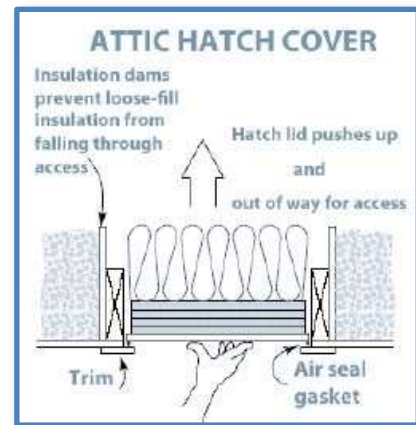
- The attic access hatch is not sealed nor insulated. This may cause some energy loss through convection. The warm air leaking into the attic area may further cause staining of the roof sheathing above the hatch area as it condenses on the cold roof sheathing and captures dust particles from the air. It is recommended that the hatch be weather stripped and insulated to the same approximate R value as the rest of the attic.
